NEW MEXICO ENVIRONMENT DEPARTMENT

Re: **Stillbrooke Homes/Santa Monica Estates; CGP; SIC 1521; NPDES Compliance Evaluation Inspection; NPDES # NMU001955; December 20, 2017**

NPDES Construction General Permit Inspection Report – State of New Mexico

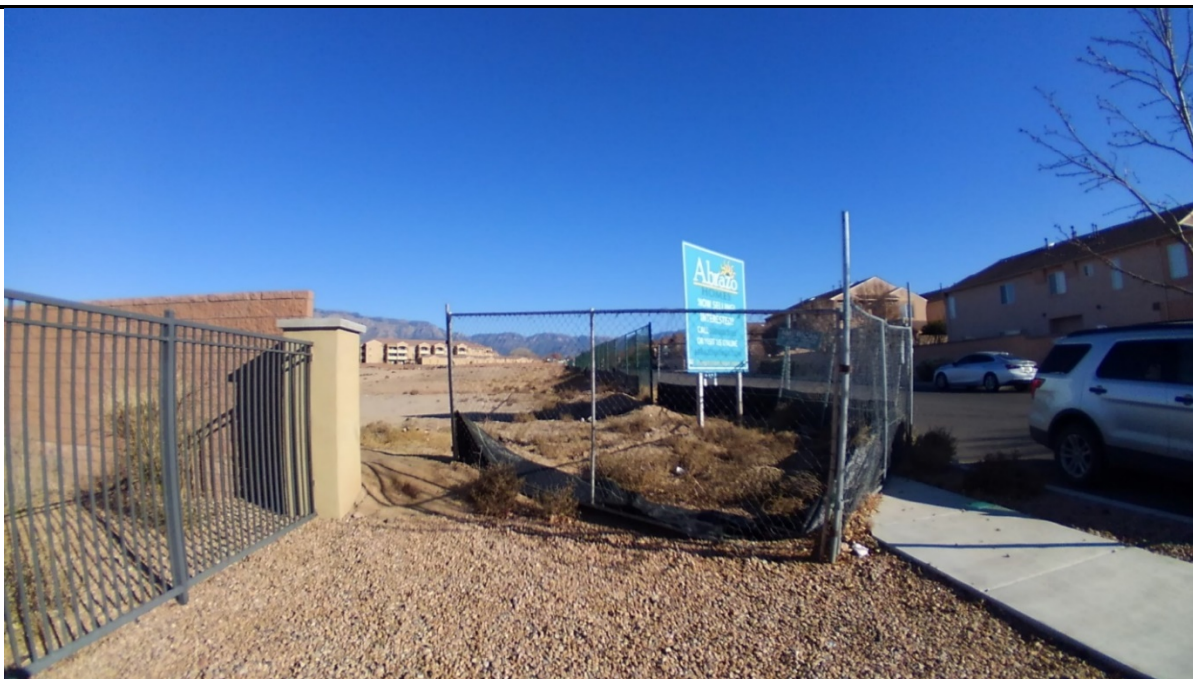
BMPs such as silt fence are not all maintained, the plan describes a low point behind the curb as the primary BMP (photos 3,4, 5, 6). There is no documentation of the date that temporary stabilization occurred or specifications that describe how long the soil tackifier is effective. Minor tracking was occurring at some of the homes (photo 5). Concrete and stucco washout was occurring around the site directly on the ground (photo 7).

NMED/SWQB Official Photograph Log Photo # 3		
Photographer: Jennifer Foote	Date: 12/20/17	Time: 2:13 pm
City/County: Albuquerque, Bernalillo		State: New Mexico
Location: Santa Monica Estates		
Subject: Undeveloped southwest corner of site, silt fence is falling down (Operator: Titan Development)

- Part 2.1.4 Stormwater controls not maintained (Abrazo Homes, TQM, Santa Monica Place Development LLC, Stillbrook Homes)
- Part 2.2.14 No record of expected longevity and date of application of temporary stabilization of soil tackifier at inactive areas (Santa Monica Place Development)
- Part 2.3.4 Leak proof or lined washout not used. (Abrazo Homes, TQM, Santa Monica Place Development LLC, Stillbrook Homes)

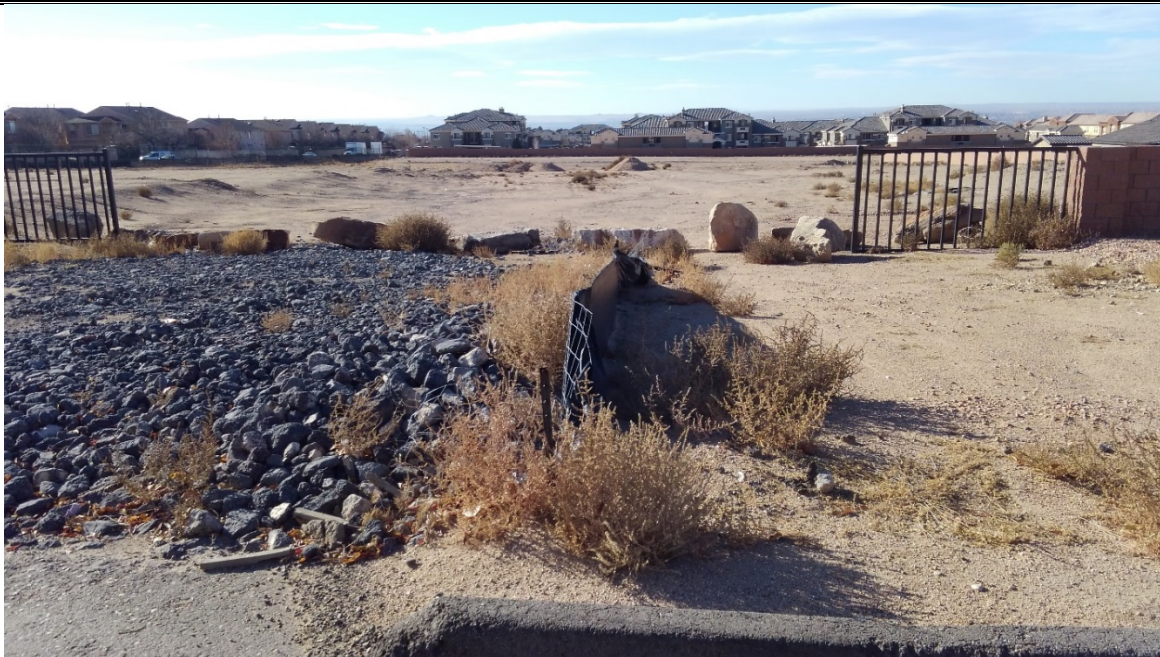
NMED/SWQB Official Photograph Log Photo # 4		
Photographer: Jennifer Foote	Date: 12/20/17	Time: 2:10 pm
City/County: Albuquerque, Bernalillo		State: New Mexico
Location: Santa Monica Estates		
Subject: abandoned construction entrance, unstabilized area at undeveloped portion of site (Operator: Titan Development)

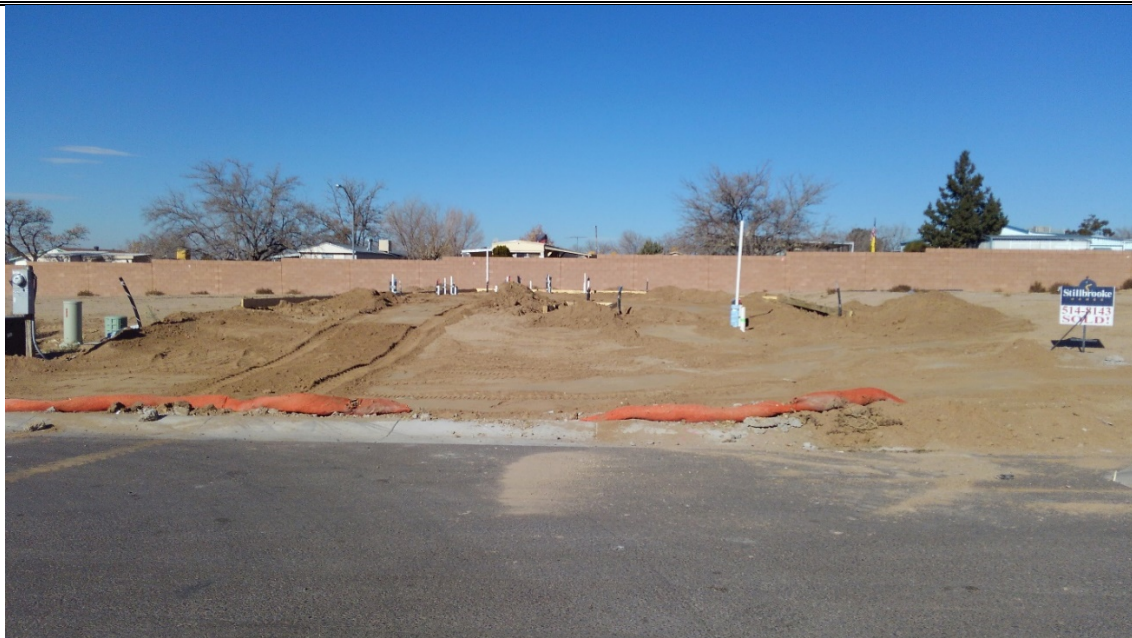
NMED/SWQB Official Photograph Log Photo # 5		
Photographer: Jennifer Foote	Date: 12/20/17	Time: 1:12 pm
City/County: Albuquerque, Bernalillo		State: New Mexico
Location: Santa Monica Estates		
Subject: tracking and BMPs in disrepair (Operator:Stillbrooke)

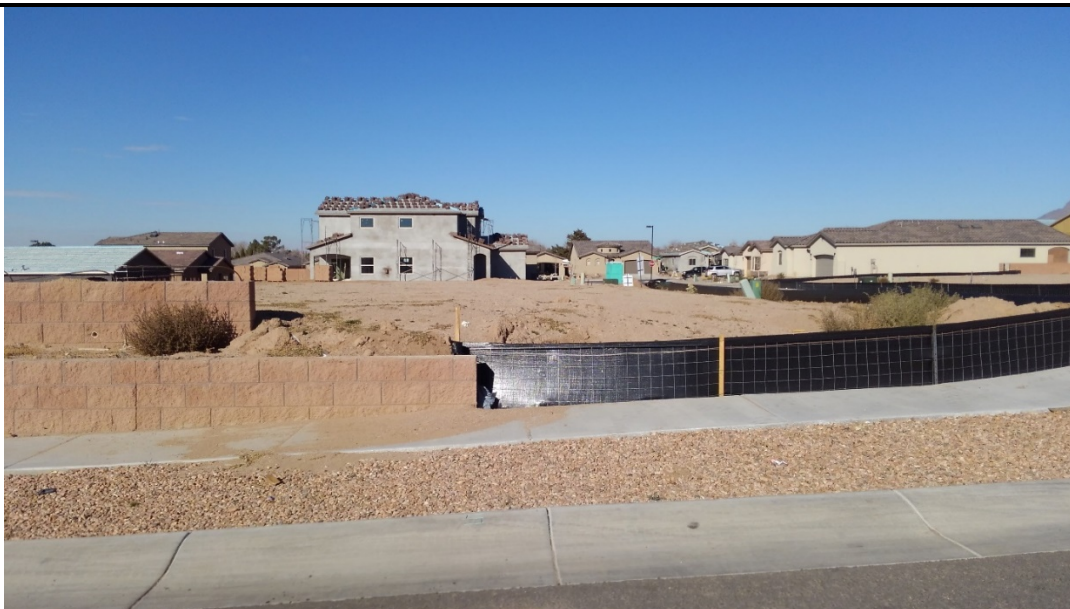
NMED/SWQB Official Photograph Log Photo # 6		
Photographer: Jennifer Foote	Date: 12/20/17	Time: 1:46 pm
City/County: Albuquerque, Bernalillo		State: New Mexico
Location: Santa Monica Estates		
Subject: sediment going under silt fence (Operator:Stillbrooke)

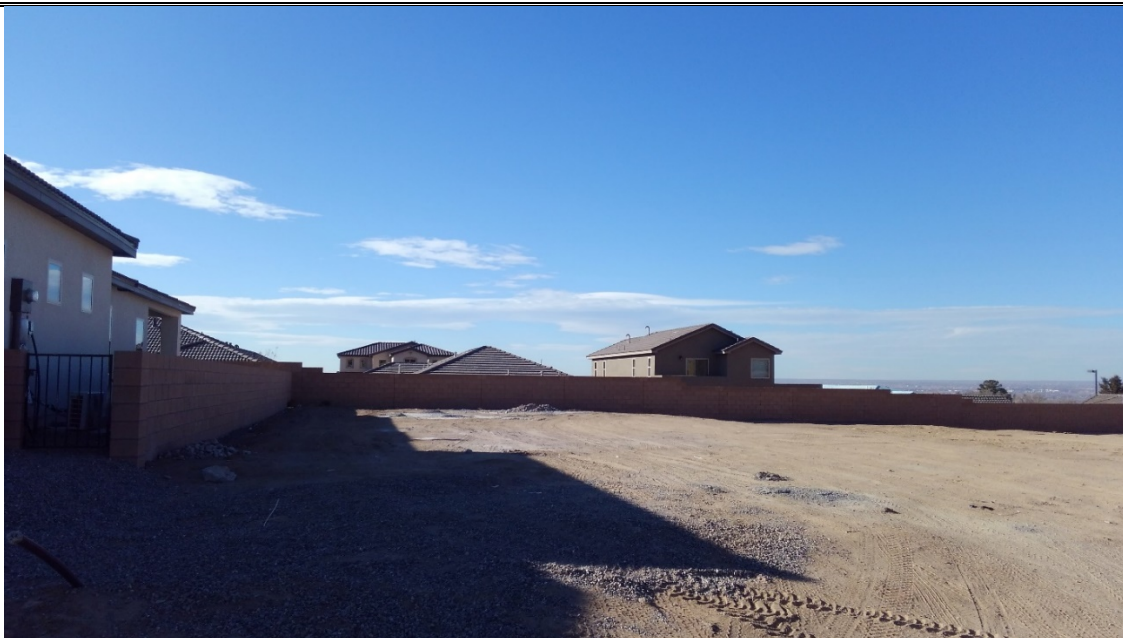
NMED/SWQB Official Photograph Log Photo # 7		
Photographer: Jennifer Foote	Date: 12/20/17	Time: 1:35 pm
City/County: Albuquerque, Bernalillo		State: New Mexico
Location: Santa Monica Estates		
Subject: concrete washout on ground BMPs in disrepair (Operator:Stillbrooke)
